# NATIONAL TRANSPORTATION SAFETY BOARD

## PIPELINE ACCIDENT REPORT

**GAS SERVICE CO.  
EXPLOSION AND FIRE  
LONDON, KENTUCKY  
JANUARY 16, 1979**

**NTSB-PAR-79-2**

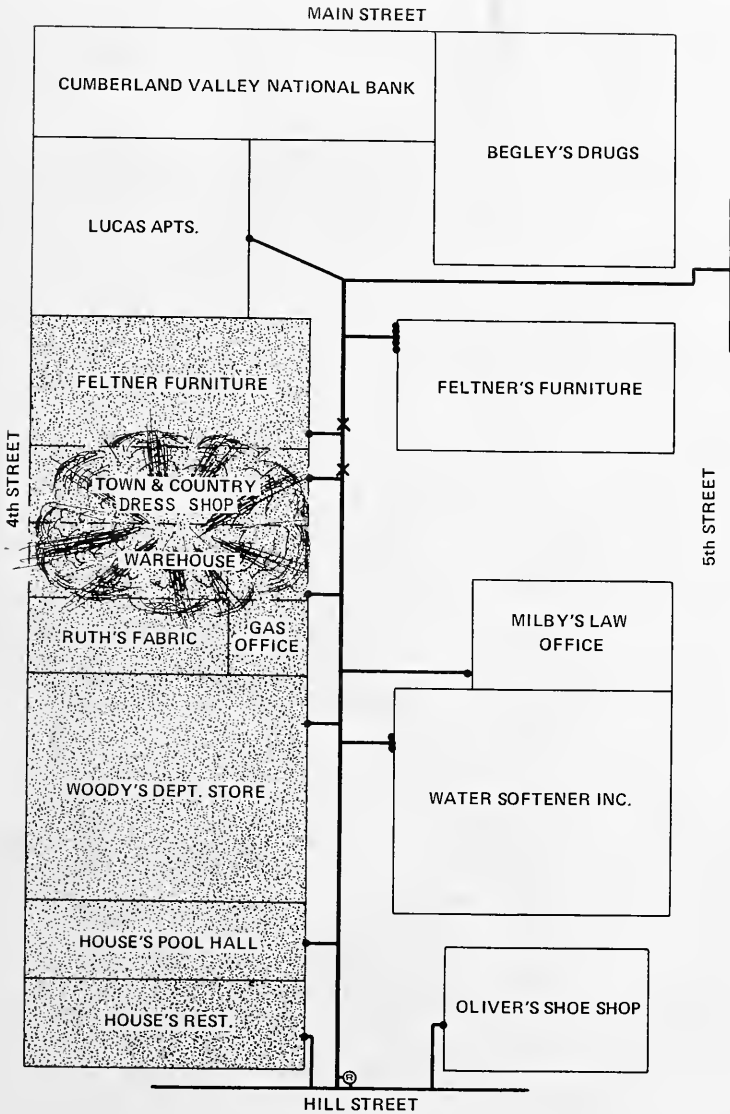
Figure 1. Plan of the accident site.

Gas company personnel commenced work at Hill Street where the 7-inch gas main was connected through a regulator to a 3-inch main to provide a loop in the low-pressure system. (See figure 1.)

On Friday, January 12, 1979, gas company personnel turned off the valves at the newly installed regulators and then increased the pressure on the 7-inch bare steel gas main from 4 ounces to 17 psig. The workers then returned to each regulator, replaced the previously removed orifice, and began relighting procedures  $\frac{2}{4}$  inside each building served by gas. One worker walked over the area to check for leaks. He did not use a combustible gas indicator (CGI) but relied upon his nose to detect the odor of gas. Although he did not check any sewer manholes, he detected two leaks: one at the corner of 5th and Main Streets -- gas was seen bubbling through standing water -- and a smaller one in the alley behind 5th Street. (See figure 1.)

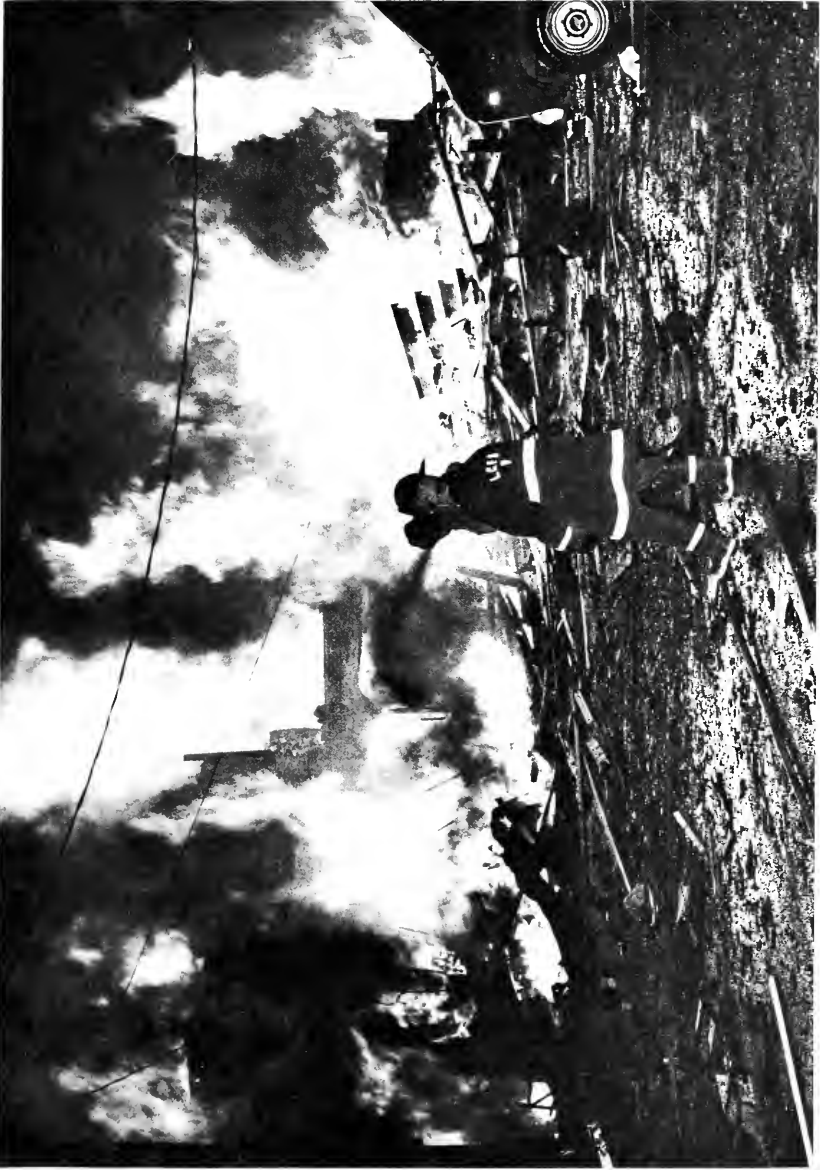
Figure 2. Explosion and fire, London, Kentucky.

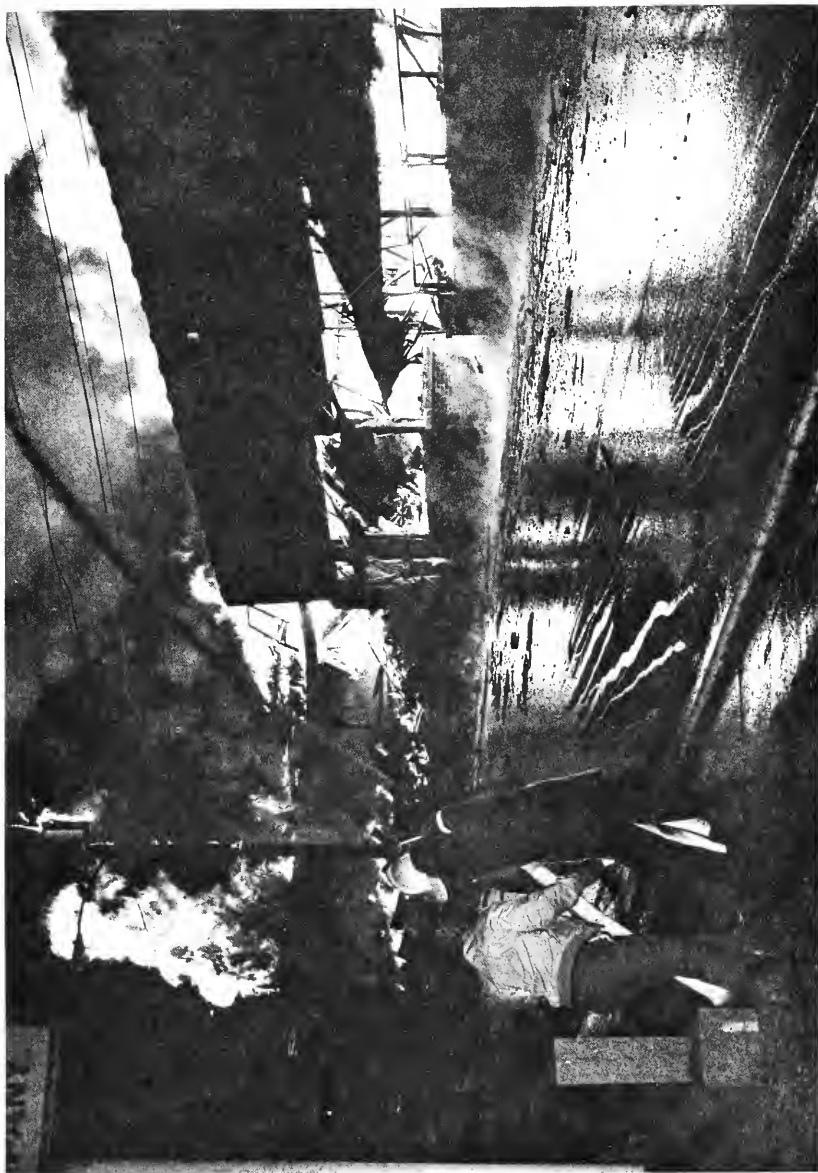
Figure 3. Explosion and fire, London, Kentucky.

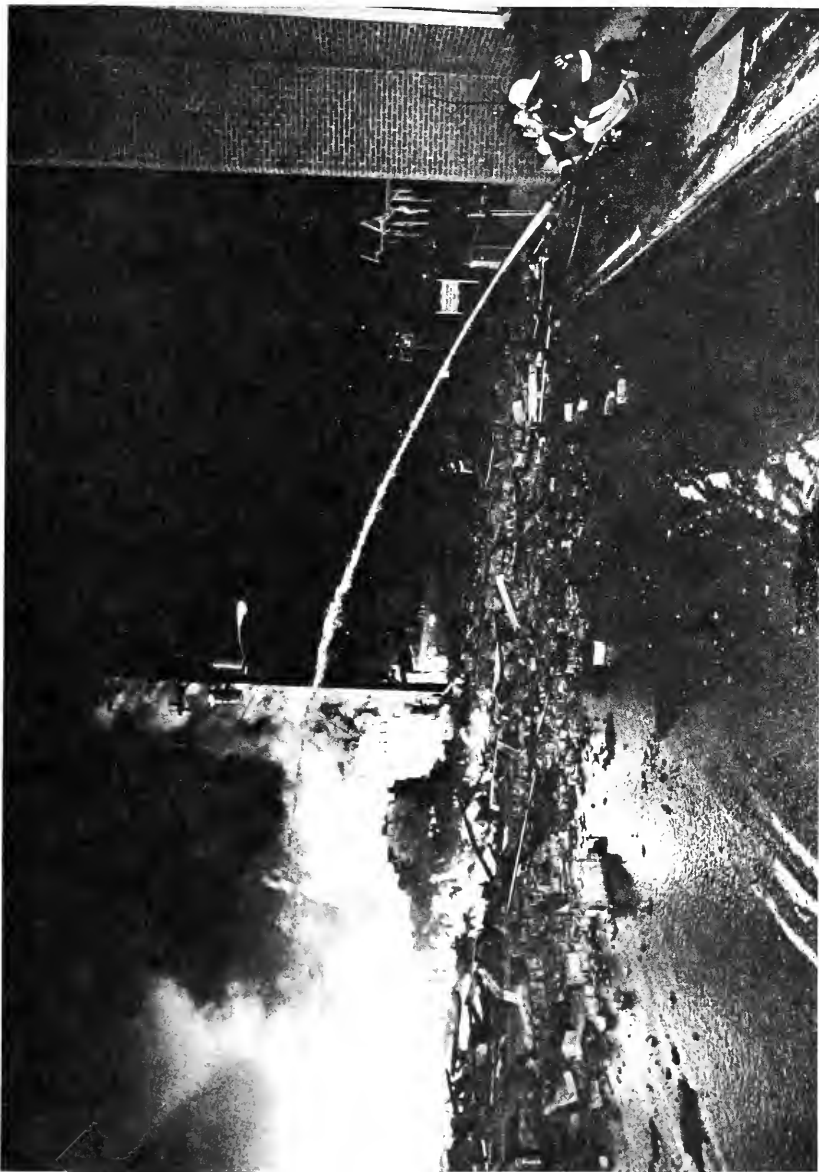
Figure 4. Explosion and fire, London, Kentucky.

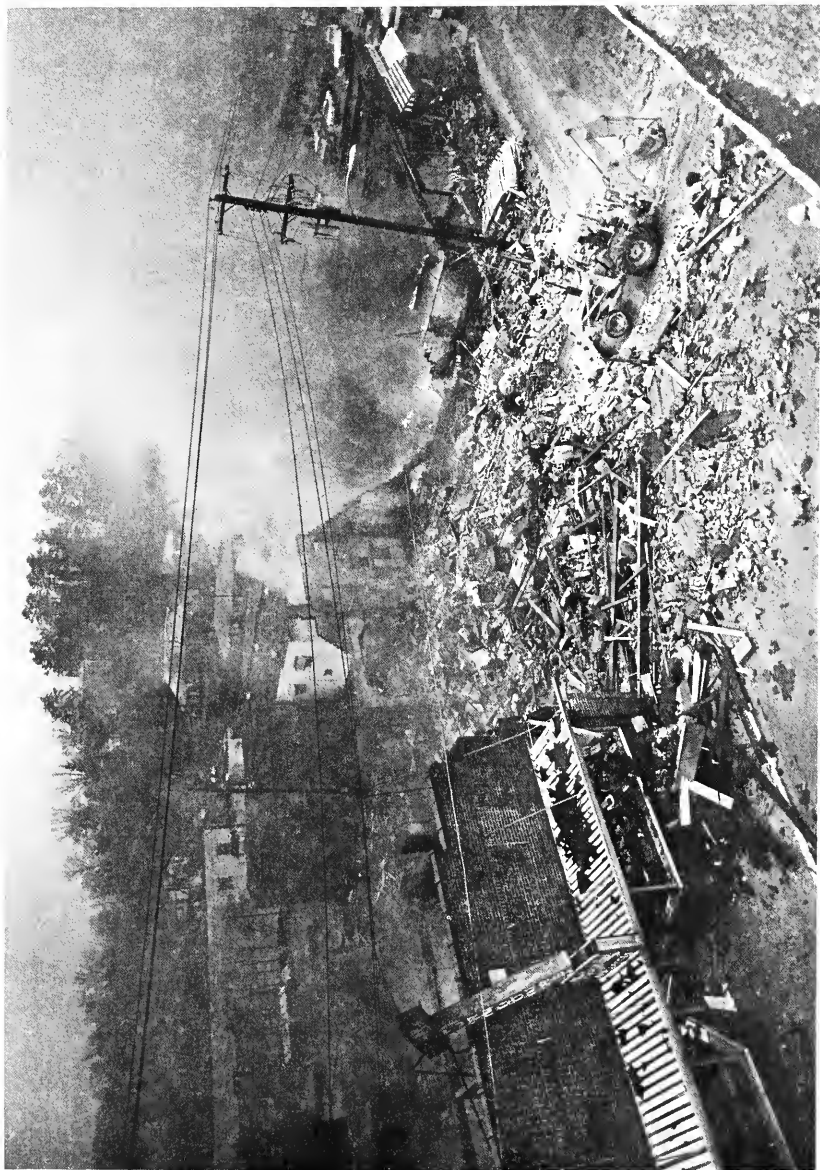
At 9:30 p.m. e.s.t., on Tuesday, January 16, 1979, natural gas, which had escaped from a large corrosion hole in the 7-inch steel gas main and had accumulated in several buildings nearby, exploded and then burned. Five buildings were destroyed, two adjacent buildings were damaged extensively, windows within a five-block radius were shattered, and a truck was damaged. Two persons were injured slightly.

Figure 5. Overall destruction, London, Kentucky.

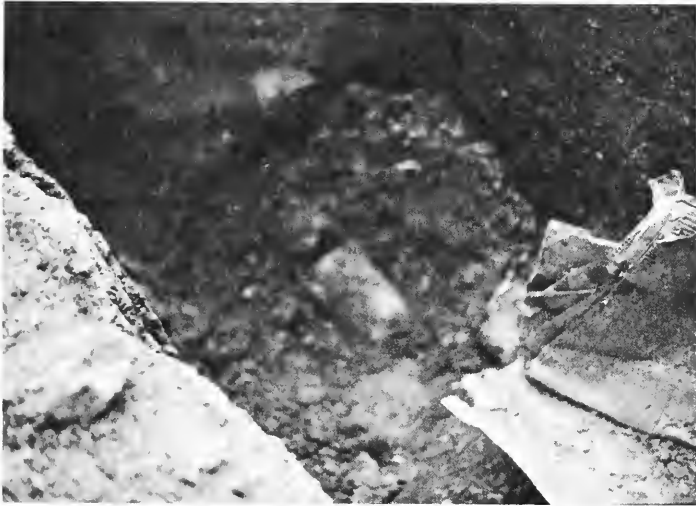
Figure 6. Broken sewerline below corrosion hole leak.

Smoke was introduced into the hole in the sewerline near the large corrosion hole in an attempt to simulate the path of the leaking gas. The smoke flowed rapidly through the sewer leads, back into the destroyed buildings, and out of the standpipes and other openings in those buildings. A large volume of smoke escaped from an empty commode in the warehouse. The basement wall between the warehouse and the Town and Country Dress Shop had ventilation openings for air circulation.

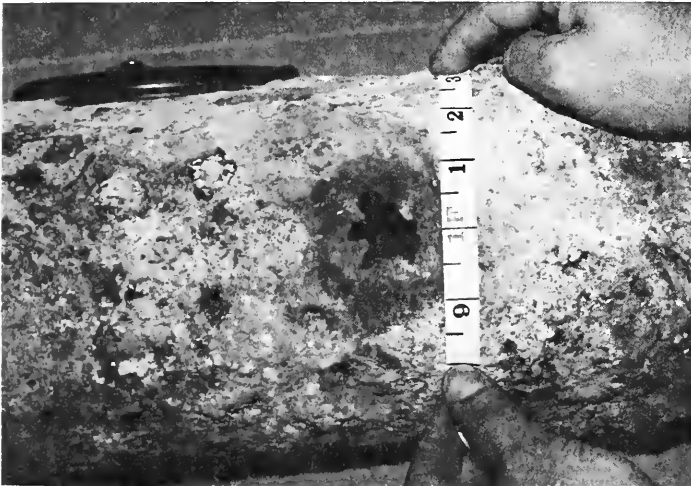
After the accident, the bare steel pipe throughout the entire alley was replaced with 2-inch plastic pipe because of its corroded condition. Two sections of the failed pipe -- the piece with the 1-inch-diameter corrosion hole and the piece with the two smaller corrosion holes -- were sent to a metallurgical laboratory for analysis. Metallurgical analysis confirmed that the pipe was steel and that the 1-inch-diameter hole was caused by external galvanic action; no internal corrosion was noted. The 1-inch-diameter hole and the two smaller corrosion holes were caused by localized galvanic action; the rest of the pipe appeared to be in good condition.

Figure 7. Corrosion hole in the pipe.

The condition of the bare, 7-inch-diameter steel gas main indicated that active corrosion had existed for a considerable time period. A complete leakage survey would have indicated this condition before the system was uprated. The bare steel pipe, which originally had been used as well casing for an unknown period of time, had been in the gas company service for 48 years; during all of this time, it had never been cathodically protected against corrosion. The gas company, to comply with Federal regulations as well as to follow its own corrosion control standards, should have surveyed the system and then applied the necessary cathodic protection before it began the uprating.

The pressure on the 1-inch-diameter corrosion hole was increased 68 times, from 1/4 psig before the accident to 17 psig. Before the accident, 57 inches of well-compacted dirt had covered the hole and had contained the gas at 1/4 psig. If the gas company personnel had increased the pressure from 1/4 psig to 8 psig, held the pressure constant (or tried to), and conducted a leak detection survey over the affected area, including a thorough check of manholes, gas leakage might have been detected. In addition, if they had monitored the gas pressure on the gas main, they might have detected the first signs of a pressure loss indicating leakage. Even if this first uprate from 1/4 psig to 8 psig did not produce any significant leakage, the second increase from 8 psig to 17 psig would probably have done so. The failure by the gas company personnel to institute a two-step increase, with monitoring after each pressure rise, was not consistent with prescribed minimum Federal safety standards.

"Determine the condition of other cathodically unprotected pipe which may be comparable to the failed pipe, and develop a schedule for system improvement based on the findings. (Class II, Priority Action) (P-79-9)
